Manhole Inspection Summary

Manhole # S39G__011MH

Insp Date: **7/14/08 9:31 AM**

Location Address: **115 Albemarle St**

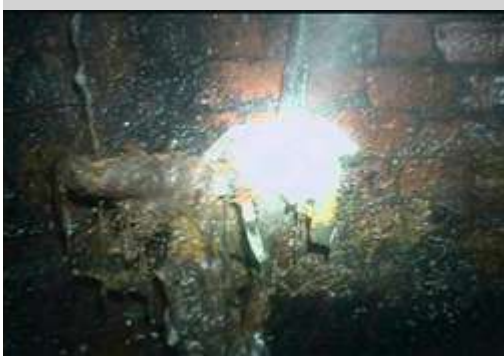
Defect 3

☒ **Evidence Of Surcharge**

evidence of surcharge

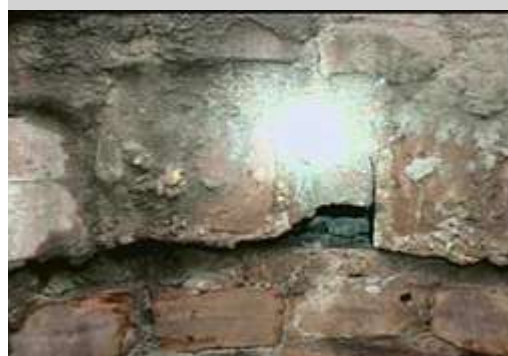
Defect 2

Condition: ☐ Sound ☐ Cracked ☐ Root Intrusion ☒ **Loose Brick** ☒ **Deteriorated**

deteriorated, loose bricks, frame adjustment

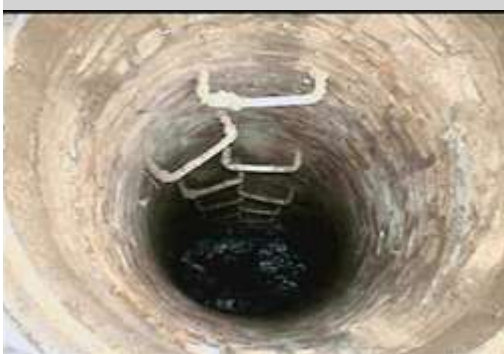
Defect 1

Count: **13** Missing: **0** ☒ **Corroded**

steps
